EROSION AND SEDIMENT CONTROL REPORT

Project:
3777.400
Tim Osmond Sports Complex
Antioch, Il. 60002

Client:
Antioch Township
1625 Deep Lake Rd.
Antioch, Il. 60002

Day & Date: Saturday, April 12, 2008
Last Visit: Thursday, April 3, 2008

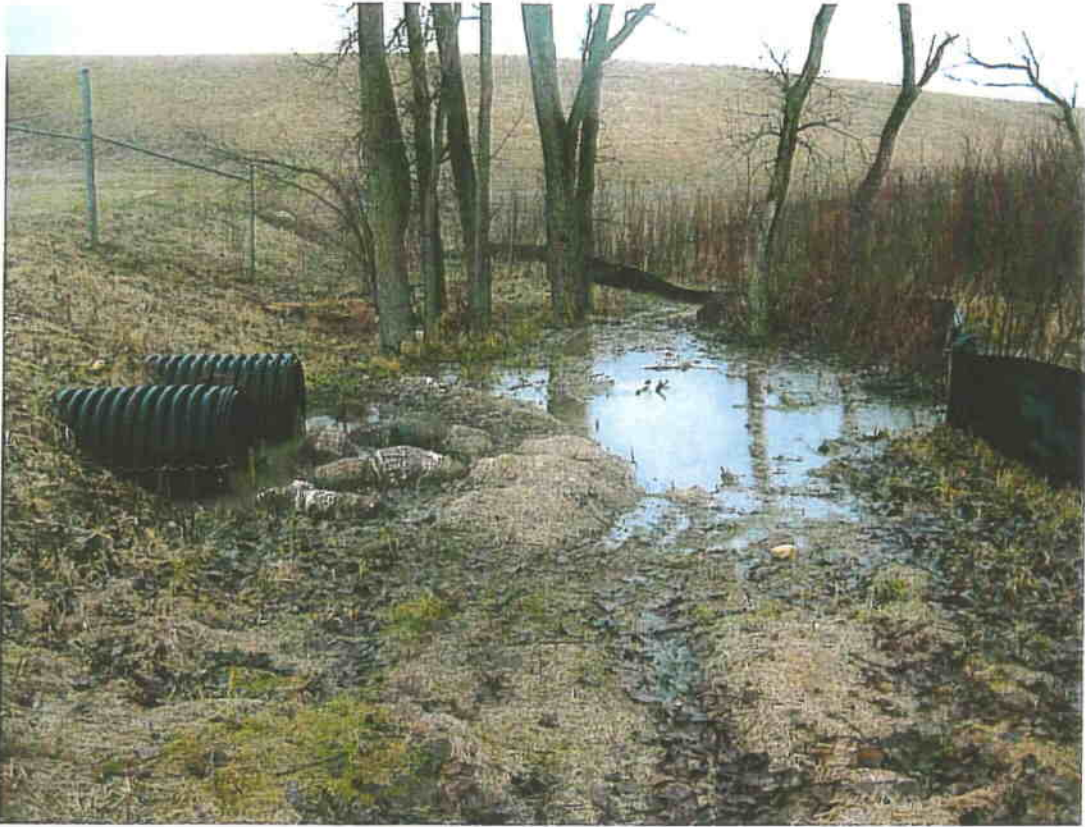
Figure 1-Install rip rap downstream of 30" culverts.

Comments: *Complete stabilization of overland flow areas. Install rip rap downstream of twin 30" culverts.*

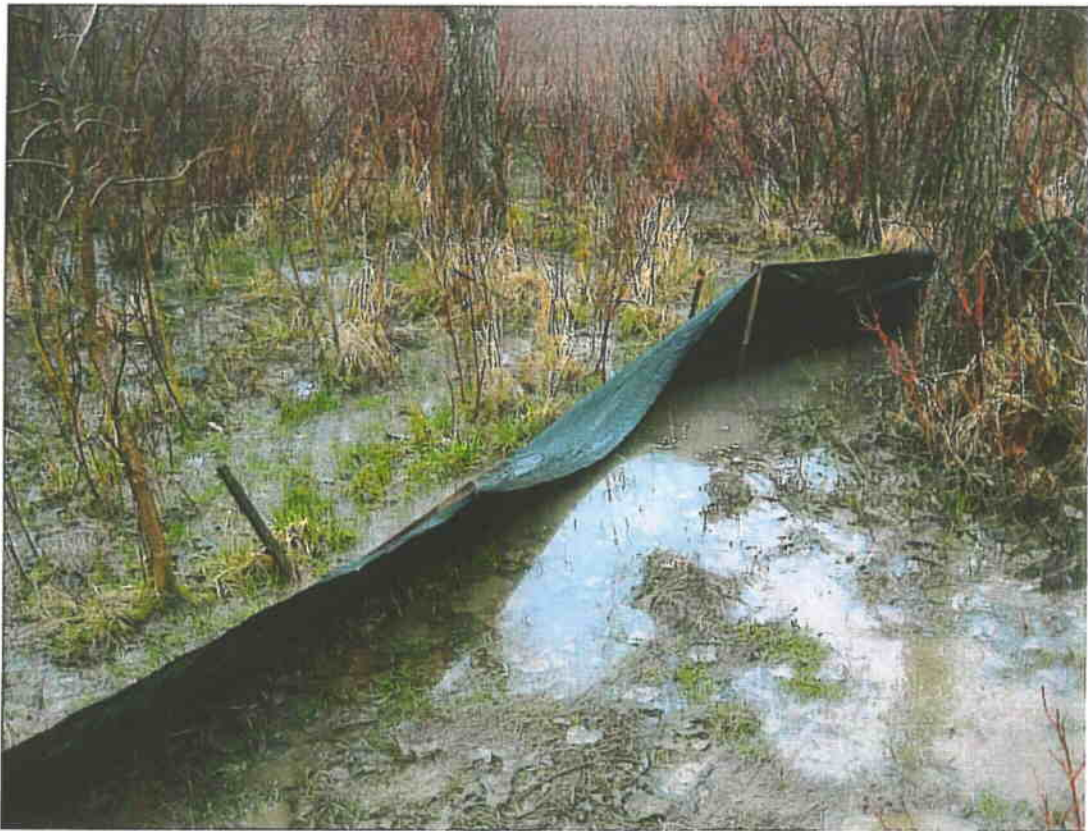
Figure 2-Repair silt fence downstream of 30" culverts.

Comments: *Repair silt fence downstream of twin 30" culverts.*

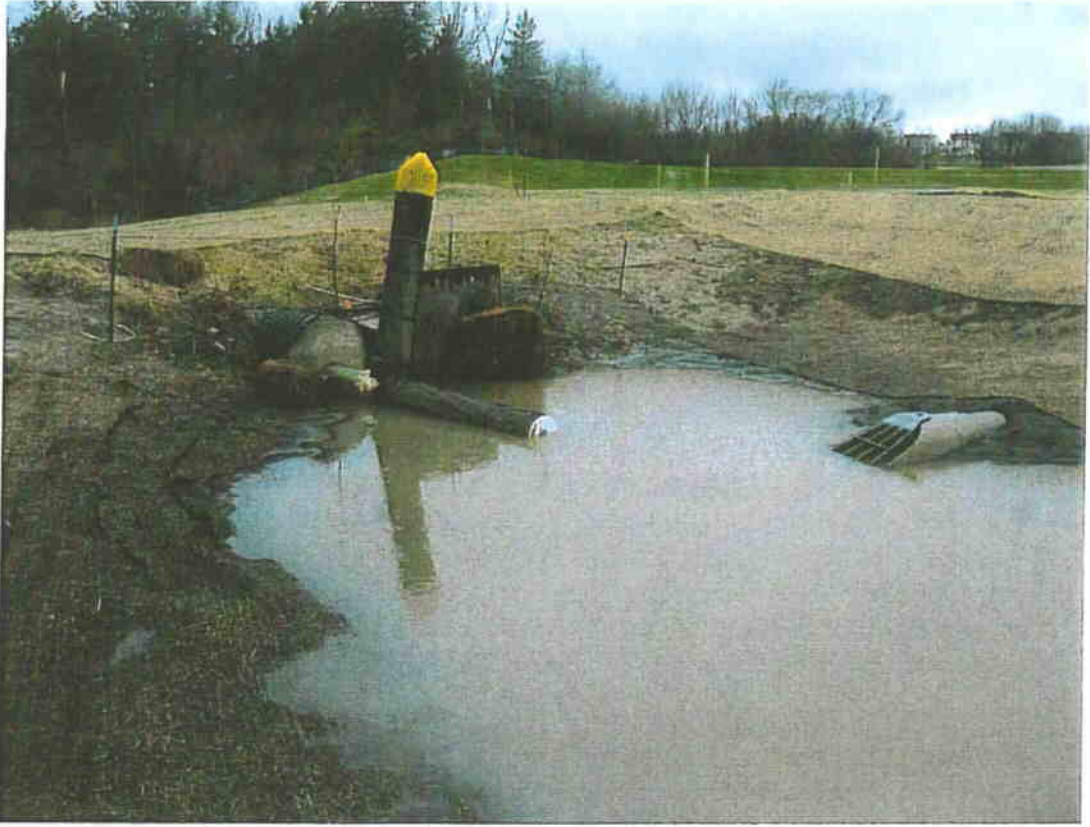
Figure 3-Perforated riser has been re-set to vertical position in basin.

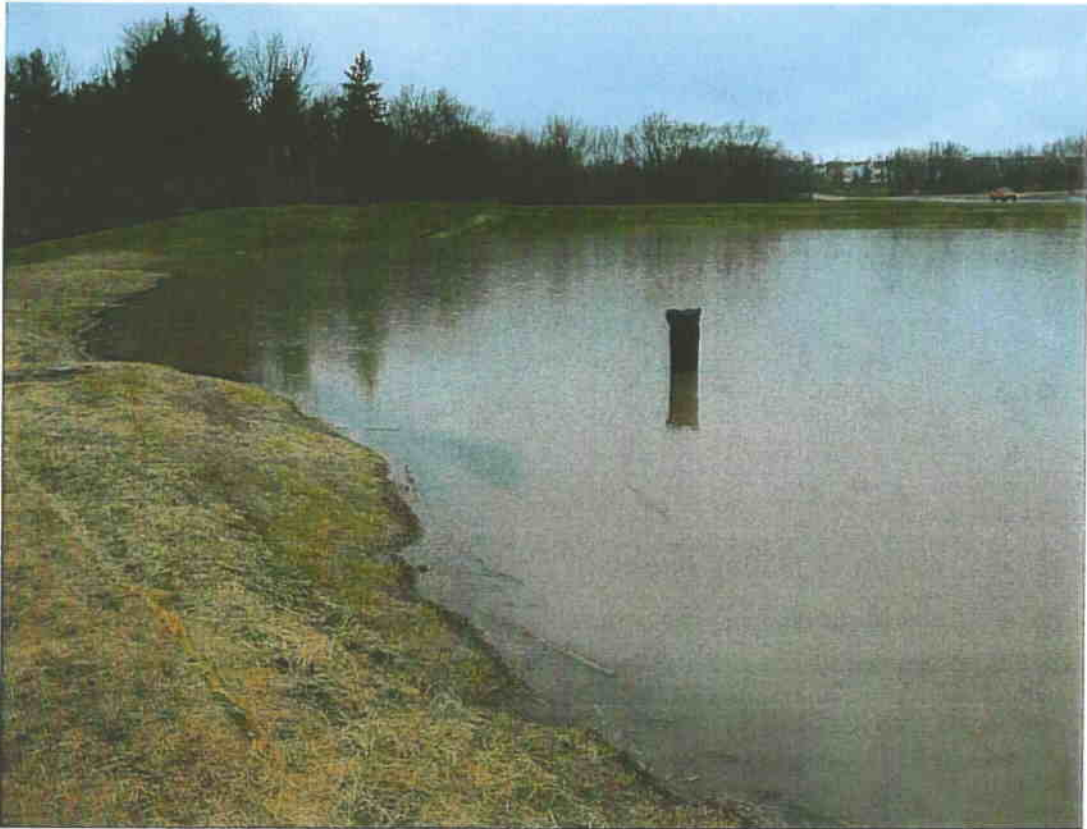
Figure 4-Perforated riser has been re-installed in pre treat area.
