EROSION AND SEDIMENT CONTROL REPORT

Project:
3777.400
Tim Osmond Sports Complex
Antioch, Il. 60002

Day & Date: Thursday, April 3, 2008
Last Visit: Thursday, March 20, 2008

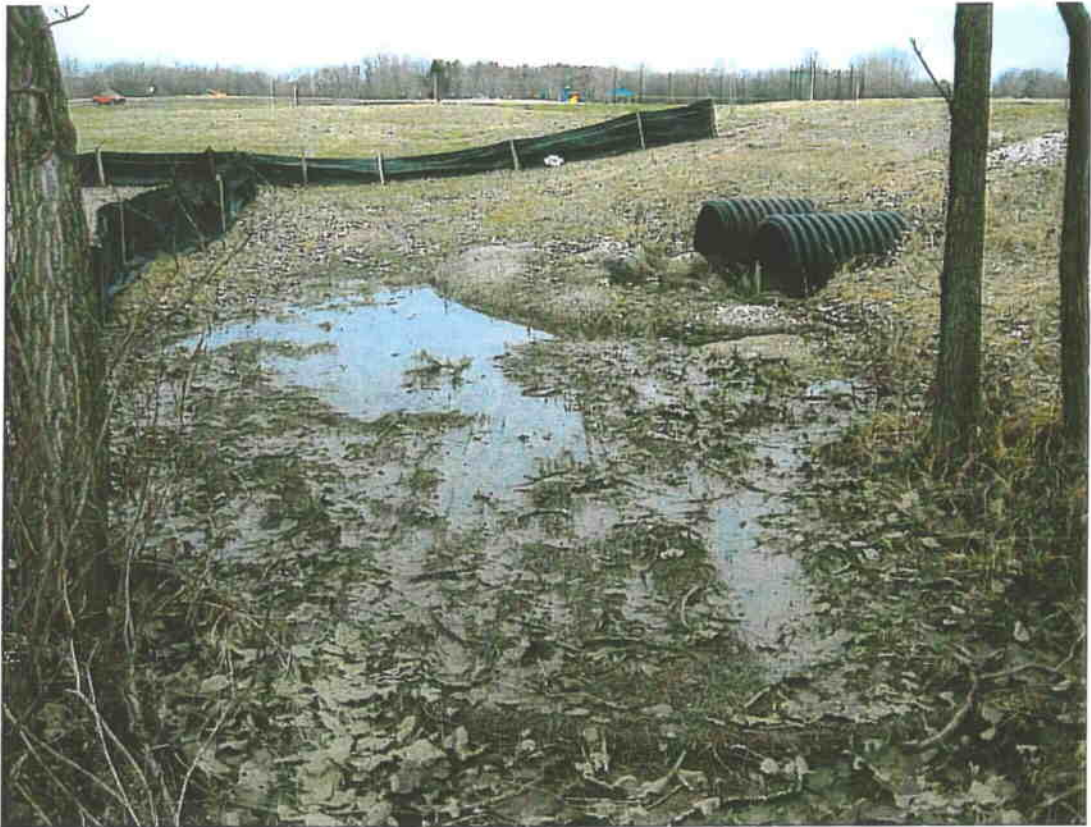
Figure 1-Place rip rap downstream of twin 30" culverts.

Are all permitted overland flow routes constructed: Yes No N/A
Are all permitted overland flow routes free from obstruction: Yes No N/A
Are all permitted overland flow routes stabilized: Yes No N/A
Are all pre-construction overland flow routes protected: Yes No N/A
Are all pre-construction overland flow routes free from obstruction: Yes No N/A
Are all points of offsite drainage (i.e. water leaving the site) stabilized: Yes No N/A
Comments: *Complete stabilization of overland flow areas. Install rip rap downstream of twin 30" culverts.*

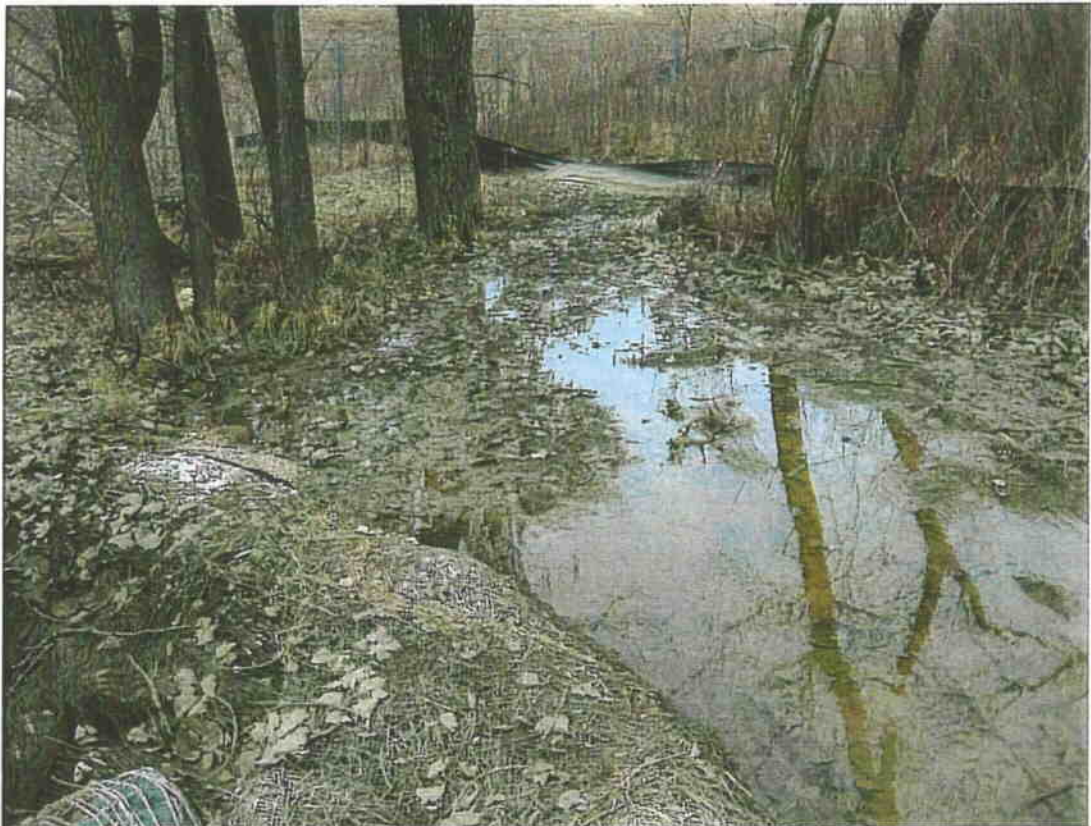
Figure 2-Repair silt fence downstream of culverts that was over run by water.

Does the silt fence meet the AASHTO 288-00 Standard: Yes No N/A
Is the silt fence installed properly: Yes No N/A
Is the silt fence maintained and in good condition: Yes No N/A
Is silt fence installed in all areas shown on the permitted plans: Yes No N/A
Comments: *Repair silt fence downstream of twin 30" culverts.*

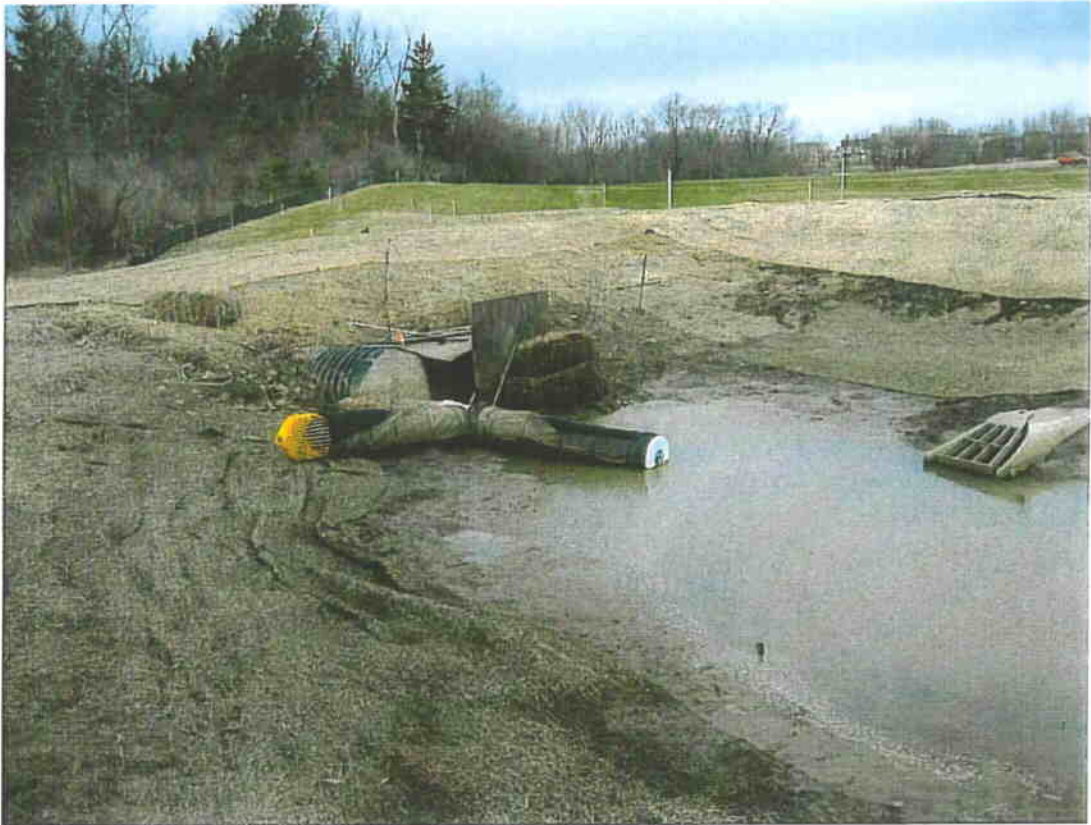
Figure 3-Re-set perforated riser to vertical position in 30" culvert.

Is the perforated riser installed: Yes No N/A
Is the perforated riser sized correctly (one pipe size smaller than the outlet pipe): Yes No N/A
Is the perforated riser wrapped with and filter fabric: Yes No N/A
Is the perforated riser adequately mortared in: Yes No N/A
Is there an adequate amount of stone at the base of the riser: Yes No N/A
Comments: *Re-install riser at flared end section SS#11. Re-set riser to vertical position in 30" PVC culvert.*

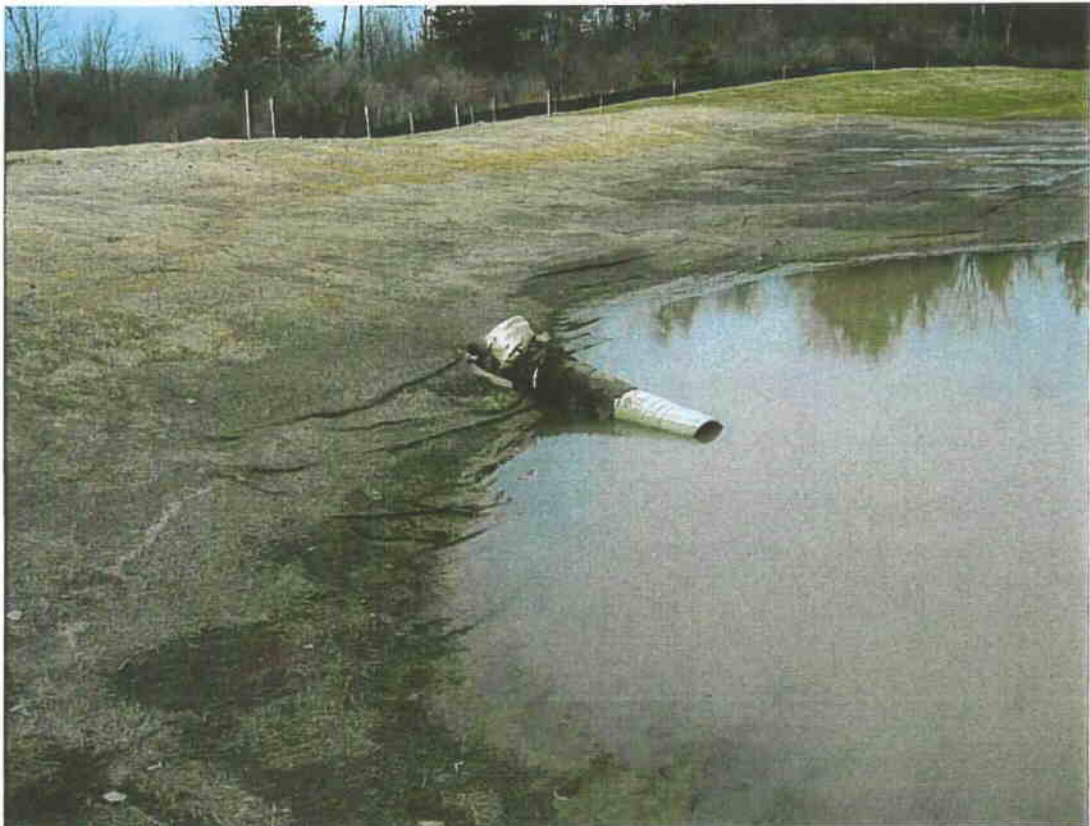
Figure 4-Re-install perforated riser in pretreat area.
