EROSION AND SEDIMENT CONTROL REPORT

Project:
3777.400
Tim Osmond Sports Complex
Antioch, Il. 60002

Client:
Antioch Township
1625 Deep Lake Rd.
Antioch, Il. 60002

March 20, 2008
March 6, 2008

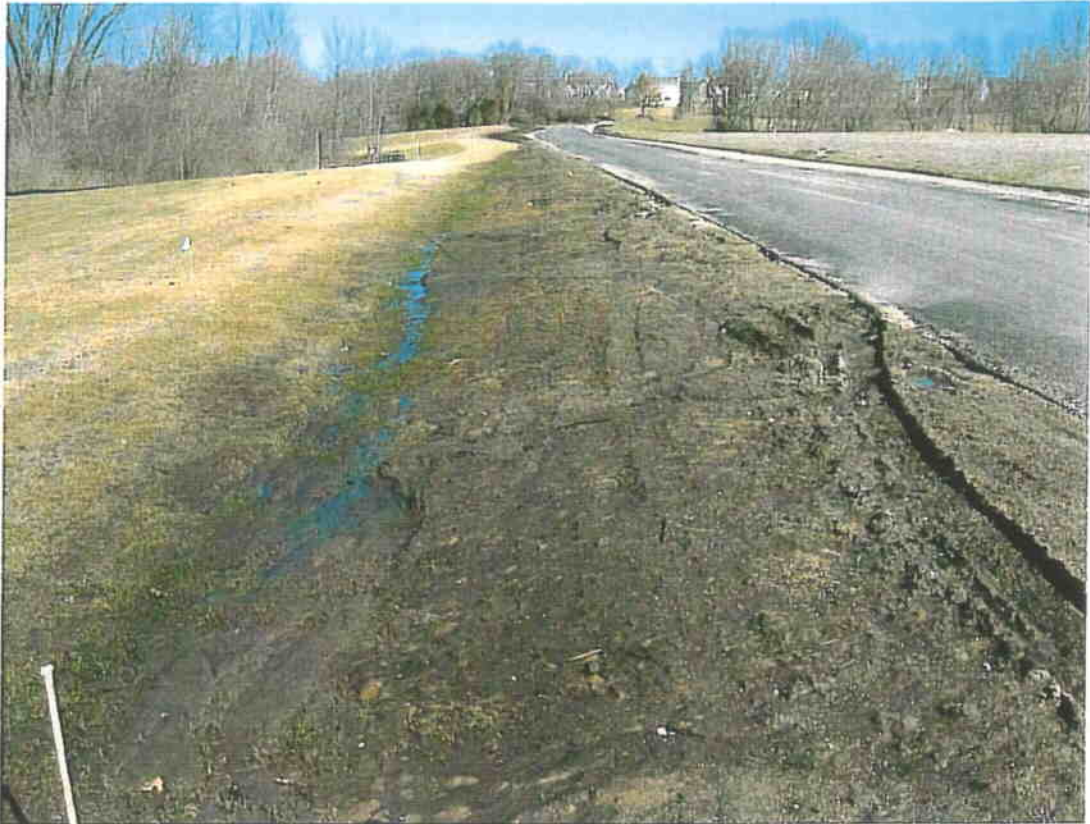
Figure 1-Stabilize area along entrance drive as weather permits.

Have all disturbed areas been stabilized with temporary or permanent measures within 14 days of the end of active hydrologic disturbance: Yes No N/A
Are stabilization measures effective: Yes No N/A
Are there areas of disturbance that need additional stabilization measures: Yes No N/A
Comments: Complete stabilization of disturbed areas as weather permits.

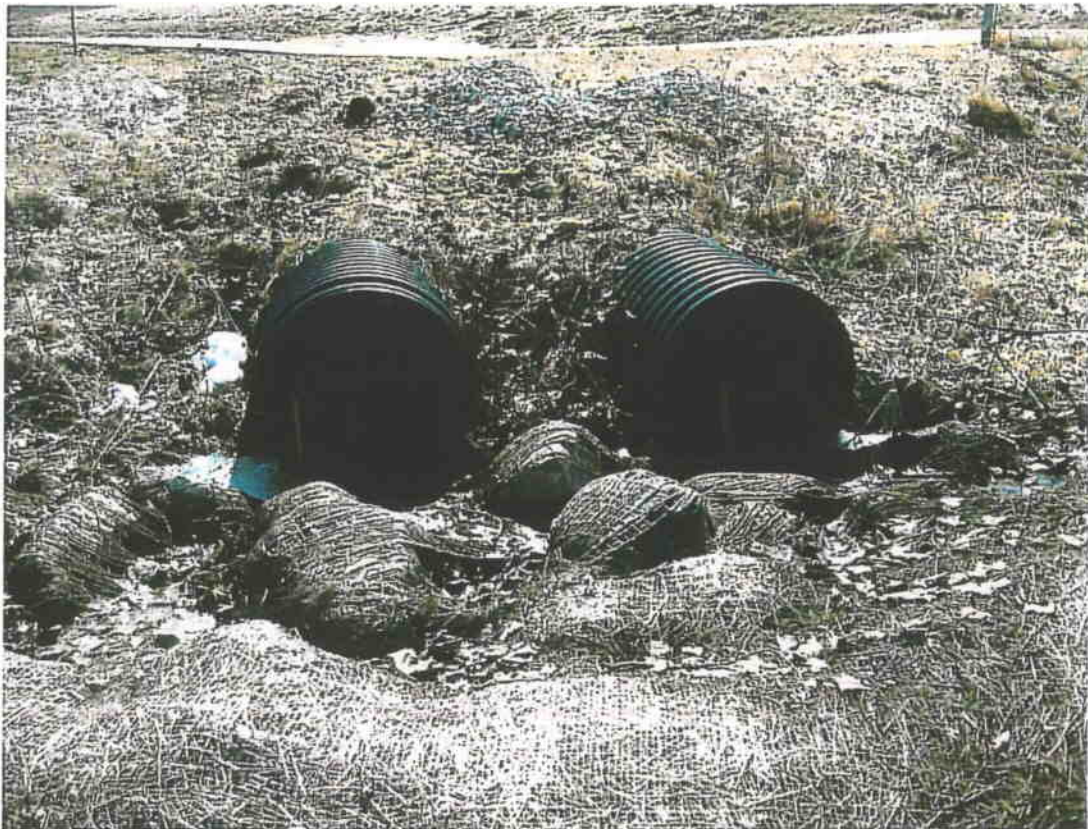
Figure 2-Install rip rap downstream of twin culverts.

Are all permitted overland flow routes constructed: Yes No N/A
Are all permitted overland flow routes free from obstruction: Yes No N/A
Are all permitted overland flow routes stabilized: Yes No N/A
Are all pre-construction overland flow routes protected: Yes No N/A
Are all pre-construction overland flow routes free from obstruction: Yes No N/A
Are all points of offsite drainage (i.e. water leaving the site) stabilized: Yes No N/A
Comments: Complete stabilization of overland flow areas as weather permits. Install rip rap downstream of twin 30" culverts.

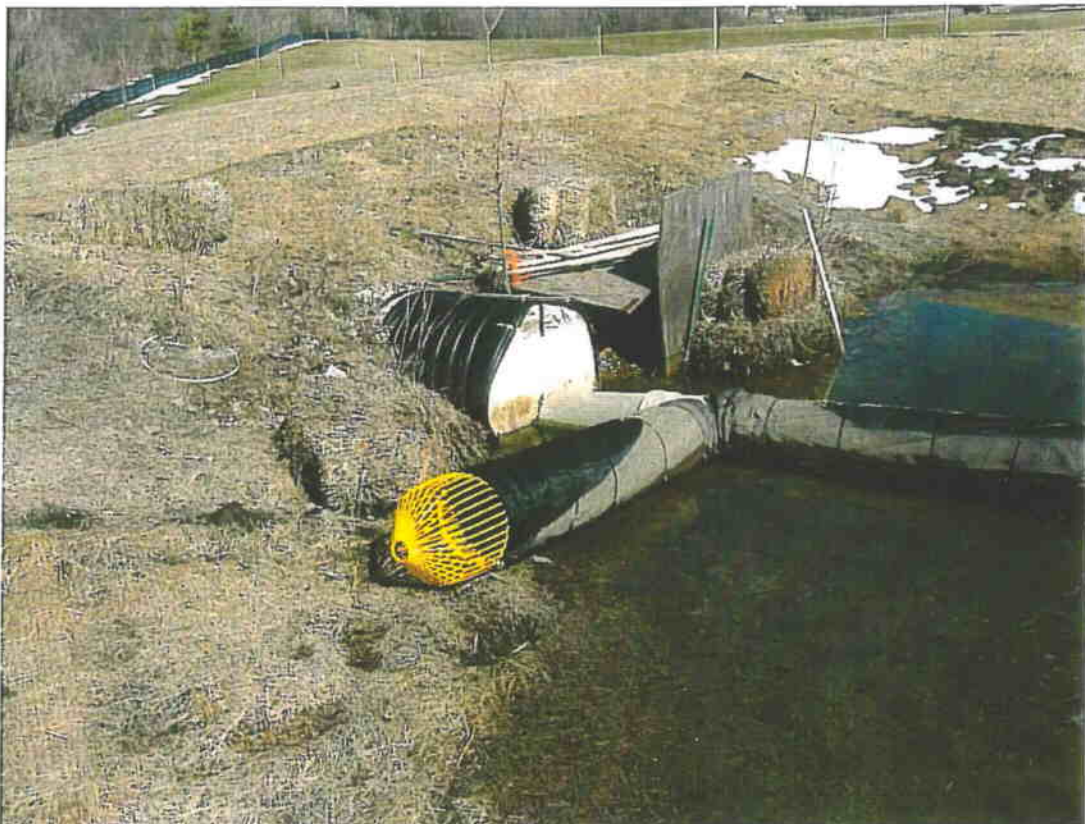
Figure 3-Re-set perforated riser to vertical position in 30" culvert.

Is the perforated riser installed: Yes No N/A
Is the perforated riser sized correctly (one pipe size smaller than the outlet pipe): Yes No N/A
Is the perforated riser wrapped with and filter fabric: Yes No N/A
Is the perforated riser adequately mortared in: Yes No N/A
Is there an adequate amount of stone at the base of the riser: Yes No N/A
Comments: Re-set riser at flared end section SS#11. Re-set riser to vertical position in 30" PVC culvert.

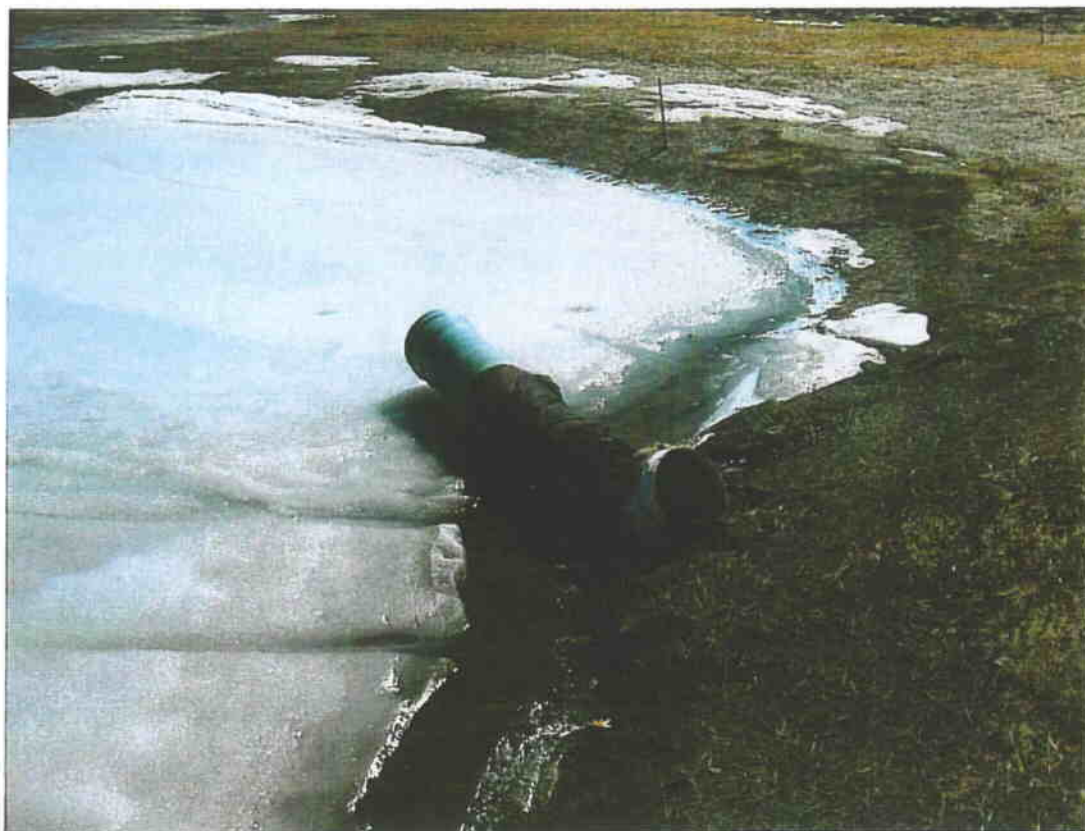
Figure 4-Re-set perforated riser in 12" flared end section SS#11.

Summary: Re-set perforated riser in flared end section SS#11. Remove sediment from inlet protection at SS#17. Complete stabilization of all disturbed areas as weather permits.
