EROSION AND SEDIMENT CONTROL REPORT

Project:
3777.400
Tim Osmond Sports Complex
Antioch, Il. 60002

Client:
Antioch Township
1625 Deep Lake Rd.
Antioch, Il. 60002

Day & Date: Friday, May 2, 2008
Last Visit: Friday, April 25, 2008

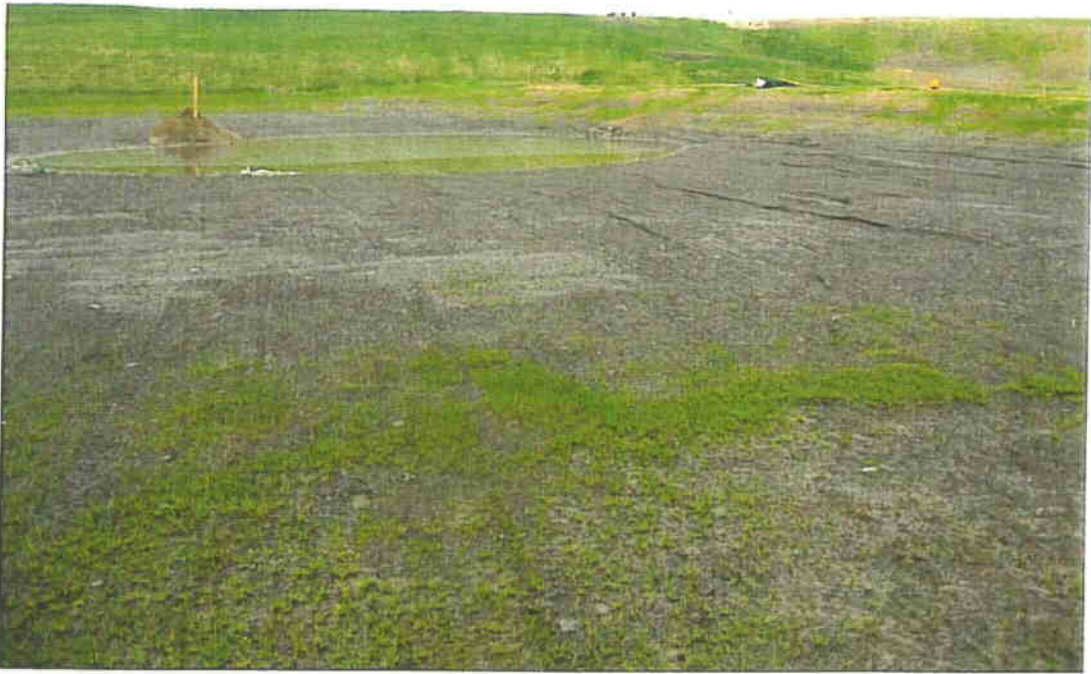
Figure 1-Pre-treat area.

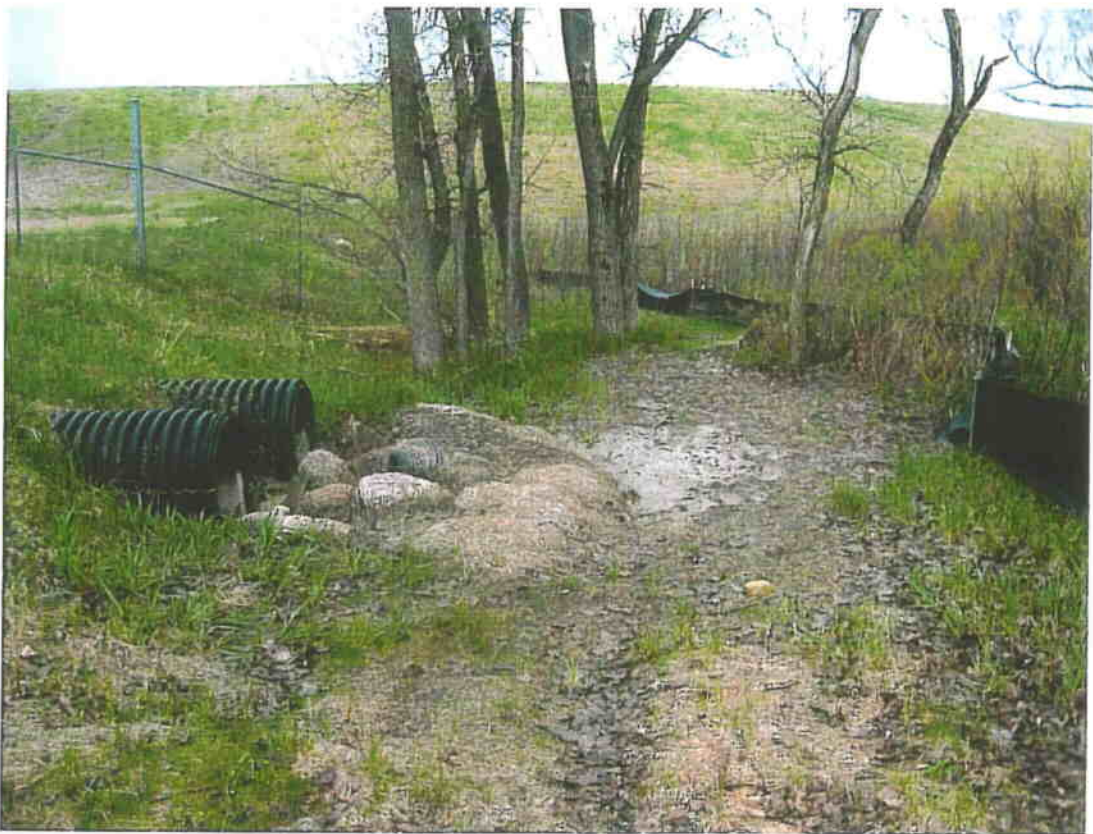
Figure 2-Place rip rap downstream of twin 30" culverts.

Are all permitted overland flow routes constructed: Yes No N/A
Are all permitted overland flow routes free from obstruction: Yes No N/A
Are all permitted overland flow routes stabilized: Yes No N/A
Are all pre-construction overland flow routes protected: Yes No N/A
Are all pre-construction overland flow routes free from obstruction: Yes No N/A
Are all points of offsite drainage (i.e. water leaving the site) stabilized: Yes No N/A
Comments: *Complete stabilization of overland flow areas. Install rip rap downstream of twin 30" culverts.*

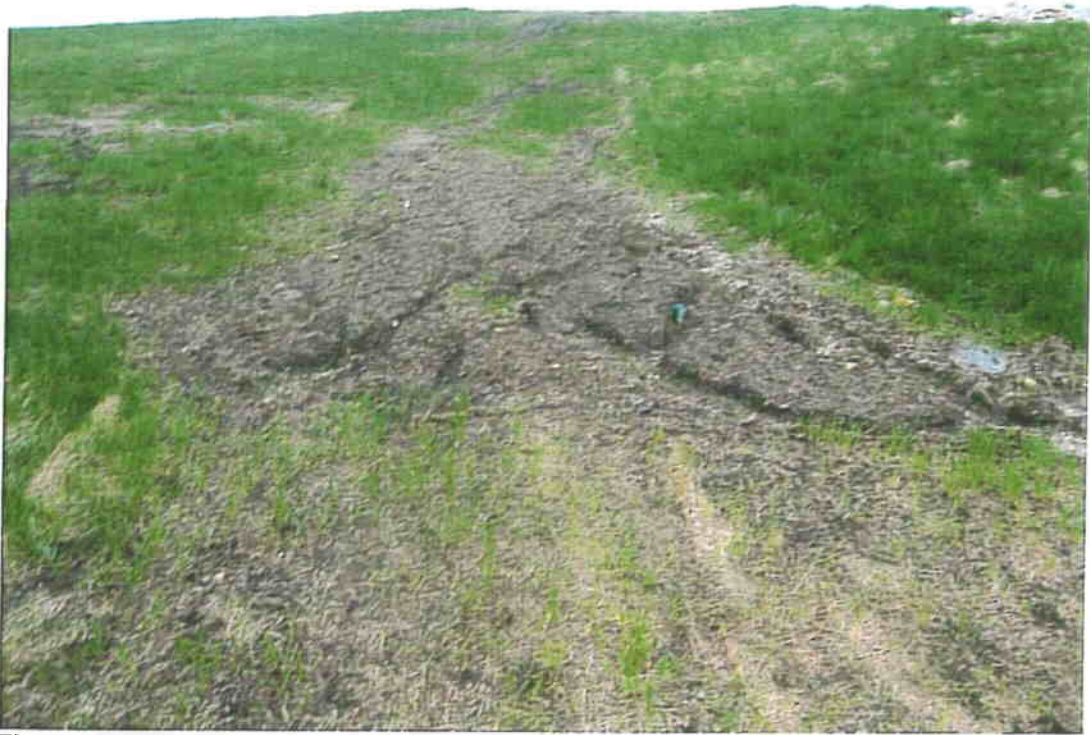
Figure 3-Stabilize area south of the basin.

Have all disturbed areas been stabilized with temporary or permanent measures within 14 days of the end of active hydrologic disturbance: Yes No N/A
Are stabilization measures effective: Yes No N/A
Are there areas of disturbance that need additional stabilization measures: Yes No N/A
Comments: *Complete stabilization of all disturbed areas.*

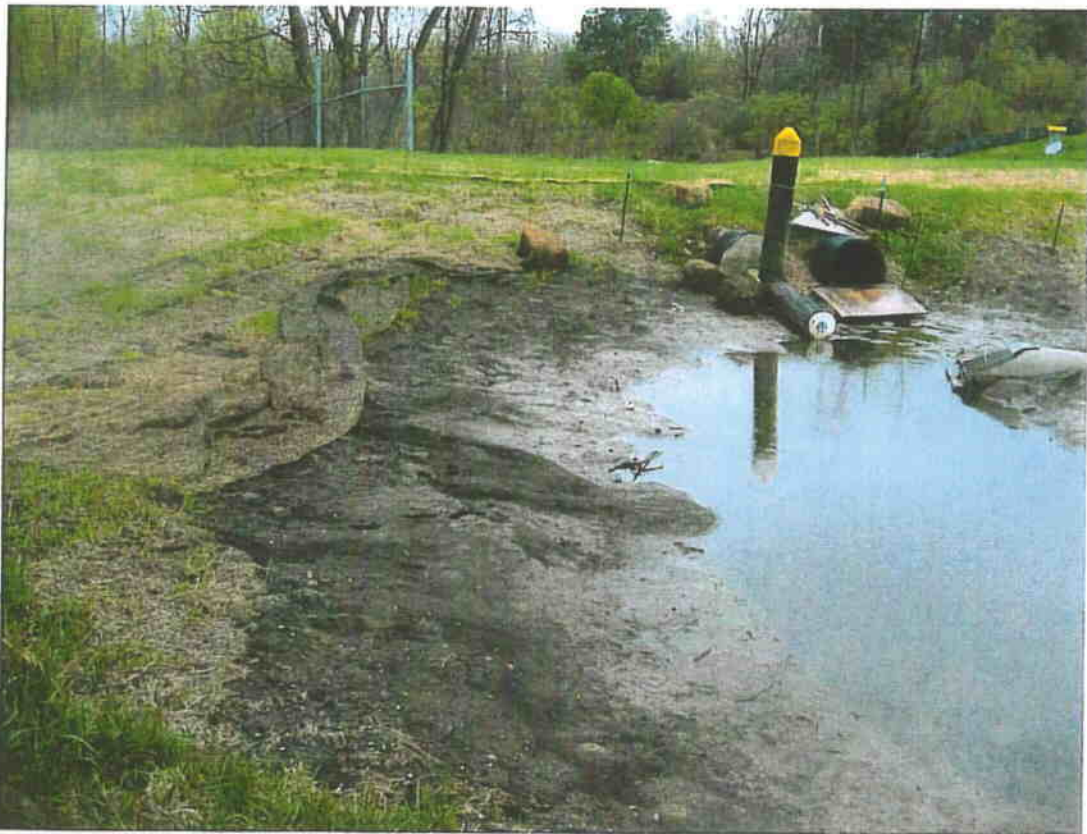
Figure 4-Re-pin erosion blanket in basin area, remove sediment from riser fabric, and seal opening of the north culvert so all storm water will flow thru the perforated riser.

Are Best Management Practices (BMP's) being used: Yes No N/A
If No, then what BMP's are recommended: *Seal opening of north 30" culvert in basin so water will filter thru perforated riser.*
Is hydrocarbon technology in place, functional and maintained where needed: Yes No N/A

Is the perforated riser installed: Yes No N/A
Is the perforated riser sized correctly (one pipe size smaller than the outlet pipe): Yes No N/A
Is the perforated riser wrapped with and filter fabric: Yes No N/A
Is the perforated riser adequately mortared in: Yes No N/A
Is there an adequate amount of stone at the base of the riser: Yes No N/A
Comments: *Remove sediment from filter fabric.*
