**EROSION AND SEDIMENT CONTROL REPORT**

**Project:**  
3777.400  
Tim Osmond Sports Complex  
Antioch, Il. 60002

**Client:**  
Antioch Township  
1625 Deep Lake Rd.  
Antioch, Il. 60002

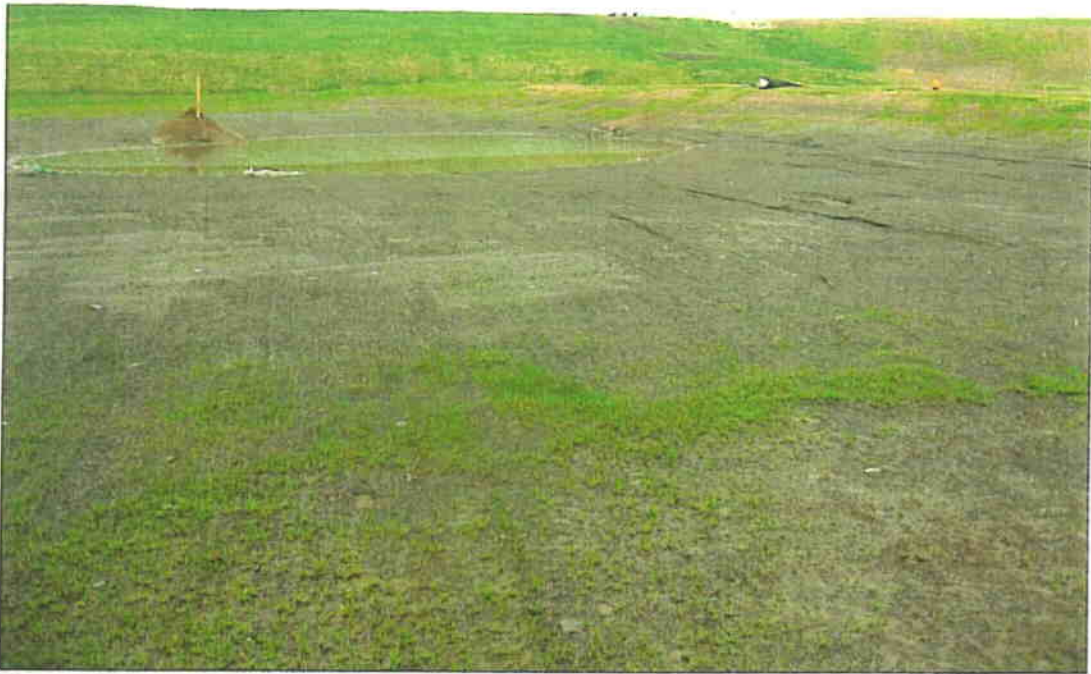
**Figure 1-Pre-treat area.**

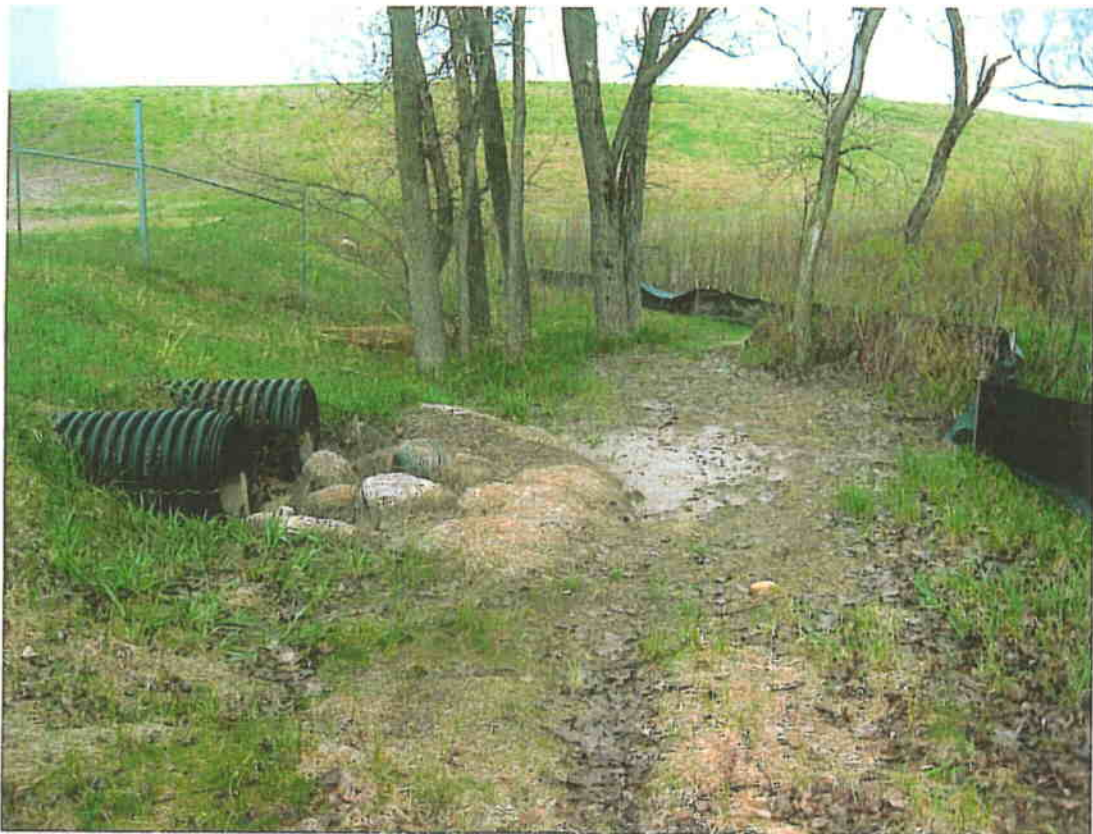
**Figure 2-Place rip rap downstream of twin 30" culverts.**

Are all permitted overland flow routes constructed:  Yes  No  N/A  
Are all permitted overland flow routes free from obstruction:  Yes  No  N/A  
Are all permitted overland flow routes stabilized:  Yes  No  N/A  
Are all pre-construction overland flow routes protected:  Yes  No  N/A  
Are all pre-construction overland flow routes free from obstruction:  Yes  No  N/A  
Are all points of offsite drainage (i.e. water leaving the site) stabilized:  Yes  No  N/A  
Comments: *Complete stabilization of overland flow areas. Install rip rap downstream of twin 30" culverts.*
